Amtrak Equipment Maintenance Department Standard Maintenance Procedure

SMP NO.: 28609

TITLE: Initial Terminal and Intermediate (1500 Mile) Wheel Inspection

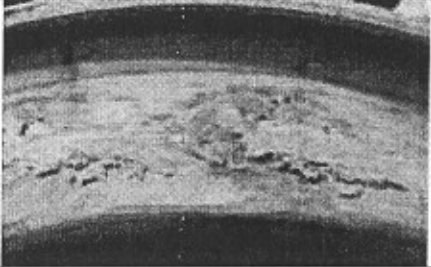
INITIAL TERMINAL			
Defect	Condemning Limit Car	Condemning Limit Locomotive	Photo
Axle	Any axle cracked, broken, or bent must be condemned	Any axle cracked, broken, or bent must be condemned	Not Available
Built up Tread	1/8" or higher than the wheel tread	1/8" or higher than the wheel tread

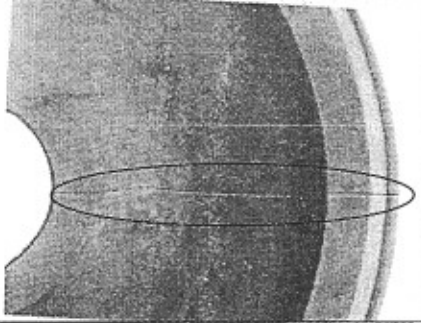
Chip or gouge in Flange	Must not be 1-1/2" or more in length and 1/2" or more in width	Must not be 1-1/2" or more in length and 1/2" or more in width	Not Available
Crack or Break in the Flange, Tread, Rim, Plate, or Hub	Any wheel with any crack or break in the Flange, Tread, Rim, Plate, or Hub must be condemned	Any wheel with any crack or break in the Flange, Tread, Rim, Plate, or Hub must be condemned

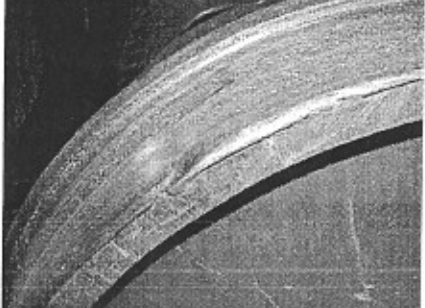
Grooved Tread, Scrape, Dent, or Gouge	1/8" or more in depth	1/8" or more in depth

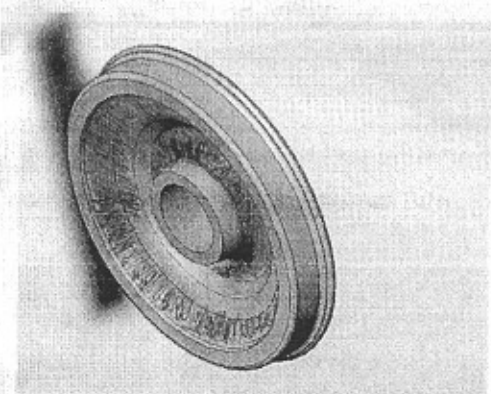
Loose or Out of Gauge	Any loose or out of gage wheels must be condemned	Any loose or out of gage wheels must be condemned	Not Available
Overheated Wheels	Wheels must not have evidence of overheating or discoloration on front and back face of rim and plate that extends 4" into the plate	Wheels must not have evidence of overheating or discoloration on front and back face of rim and plate that extends 4" into the plate

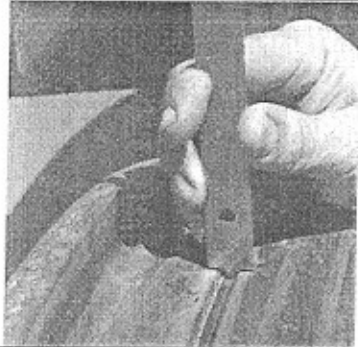
INITIAL TERMINAL			
Defect	Condemning Limit Car	Condemning Limit Locomotive	Photo
Seam	Seam (grooved tread) running lengthwise within 3-3/4" of the flange or 1/8" or more in depth	Seam running lengthwise that is within 3-3/4" of the flange

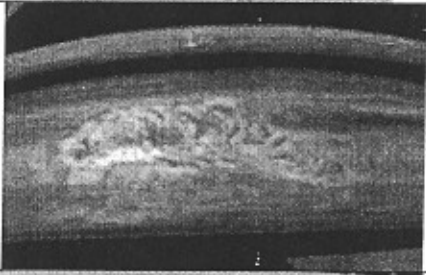
Shelling/Spalling	1-1/2" or more in length (1-1/4" Transport Canada)	1-1/2" or more in length

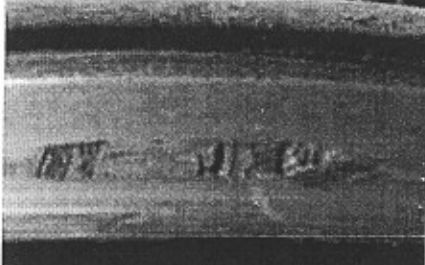
Slide Flat	1-1/2" or more in length	1-1/2" or more in length

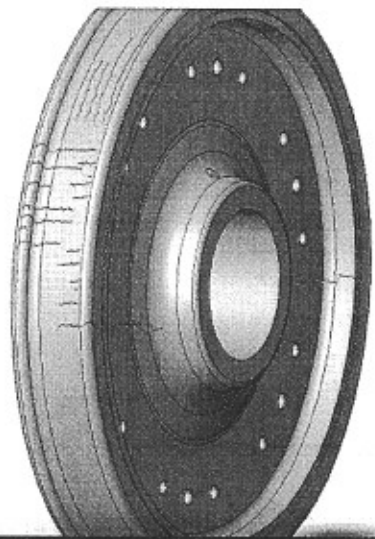
INITIAL TERMINAL			
Defect	Condemning Limit Car	Condemning Limit Locomotive	Photo
<p>**Thermal Cracks, caused by intense brake heating. Appear as small, often jagged breaks or tears in the metal, and usually start in the flange or tread, extending crosswise (Refer to pg. 11)</p>	Thermally-cracked wheels are subject to sudden and complete failure, and any wheel exhibiting any stage or degree of thermal cracking should be removed from service	Thermally-cracked wheels are subject to sudden and complete failure, and any wheel exhibiting any stage or degree of thermal cracking should be removed from service

Thermal Cracks – Thermal Cracking is caused by excessive heat on the wheel tread during heavy and repeated brake applications. The high carbon content of class "C" wheels makes them susceptible to this condition. Although high carbon wheels are produced for their wear properties under heavy loads, the high carbon content puts them at a disadvantage where severe or abnormal braking is encountered daily. Thermal Cracks are not to be confused with Heat Checks! Thermal cracks are pronounced lines that usually extend across the wheel tread in a random pattern. Severe Thermal Cracking may travel downward radially through the wheel plate and into the hub. If on inspection the wheel shows any of these conditions it must be removed and scraped.

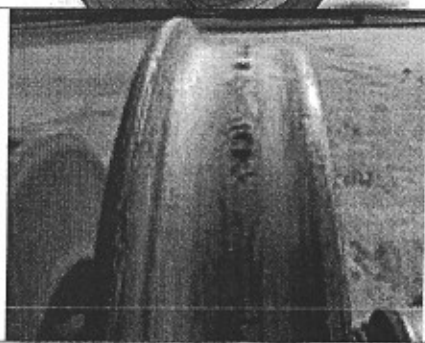
Thin Flange	Flange thickness must not be 1" or less.	Flange thickness must not be 1" or less

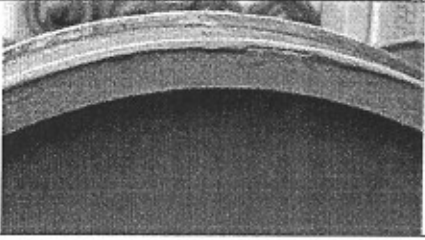
Thin Rim	Rim thickness must not be 1-1/16" or less.	Rim thickness must not be 1-1/16" or less

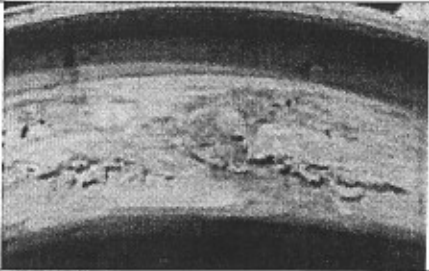
INTERMEDIATE (1500 mile)			
Defect	Condemning Limit Car	Condemning Limit Locomotive	Photo
Axle	Any axle cracked, broken, or bent must be condemned	Any axle cracked, broken, or bent must be condemned	Not Available
Built up Tread	1/8" or higher than the wheel tread	1/8" or higher than the wheel tread

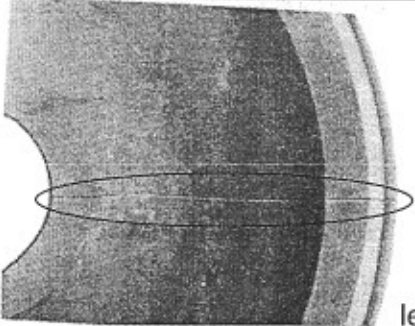
Chip or gouge in Flange	Must not be 1-1/2" or more in length and 1/2" or more in width	Must not be 1-1/2" or more in length and 1/2" or more in width	Not Available
Crack or Break in the Flange, Tread, Rim, Plate, or Hub	Any wheel with any crack or break in the Flange, Tread, Rim, Plate, or Hub must be condemned	Any wheel with any crack or break in the Flange, Tread, Rim, Plate, or Hub must be condemned

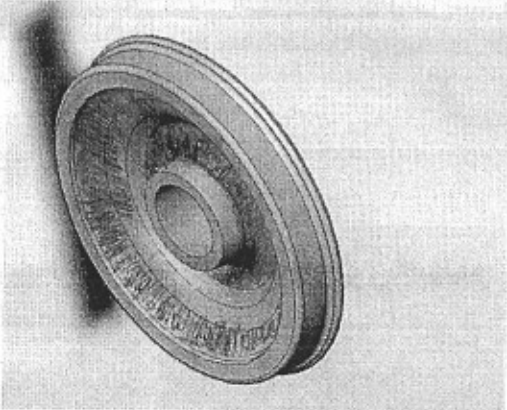
Loose or Out of Gauge	Any loose or out of gage wheels must be condemned	Any loose or out of gage wheels must be condemned	Not Available
Overheated Wheels	Wheels must not have evidence of overheating or discoloration on front and back face of rim and plate that extends 4" into the plate	Wheels must not have evidence of overheating or discoloration on front and back face of rim and plate that extends 4" into the plate

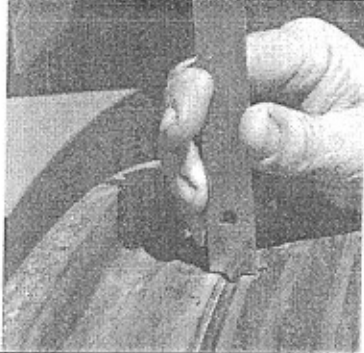
INTERMEDIATE (1500 mile)			
Defect	Condemning Limit Car	Condemning Limit Locomotive	Photo
Seam	Seam (grooved tread) running lengthwise within 3-3/4" of the flange and 1/8" or more in depth	Seam running lengthwise that is within 3-3/4" of the flange

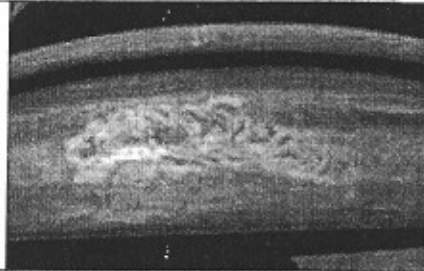
Shelling/Spalling	1-1/2" or more in length (1-1/4" Transport Canada)	1-1/2" or more in length

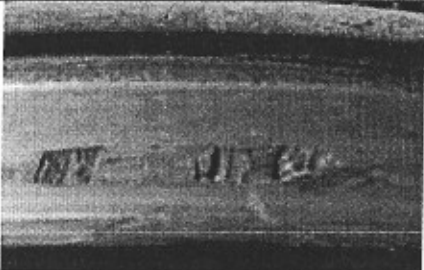
Slide Flat	1-1/2" or more in length	1-1/2" or more in length

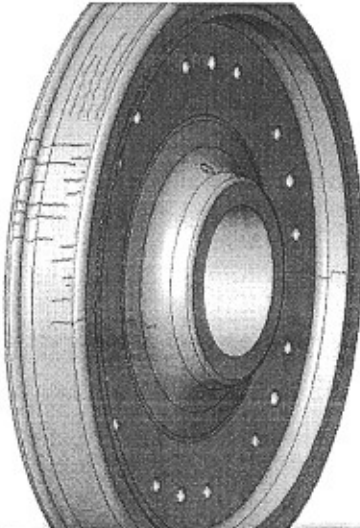
**Thermal Cracks, caused by intense brake heating. Appear as small, often jagged breaks or tears in the metal, and usually start in the flange or tread, extending crosswise (Refer to pg. 11)	Thermally-cracked wheels are subject to sudden and complete failure, and any wheel exhibiting any stage or degree of thermal cracking should be removed from service	Thermally-cracked wheels are subject to sudden and complete failure, and any wheel exhibiting any stage or degree of thermal cracking should be removed from service

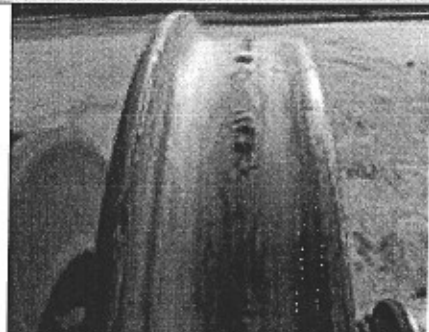
INTERMEDIATE (1500 mile)			
Defect	Condemning Limit Car	Condemning Limit Locomotive	Photo
Thin Flange	Flange thickness must not be 15/16" or less	Flange thickness must not be 15/16" or less

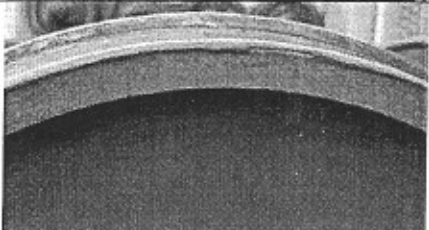
Thin Rim	Rim thickness must not be 1" or less	Rim thickness must not be 1" or less
